AZTEC RUINS NATIONAL MONUMENT
ADMINISTRATIVE HISTORY OF AN ARCHEOLOGICAL PRESERVE

Robert H. Lister and Florence C. Lister

PROFESSIONAL PAPERS NO. 24

1990

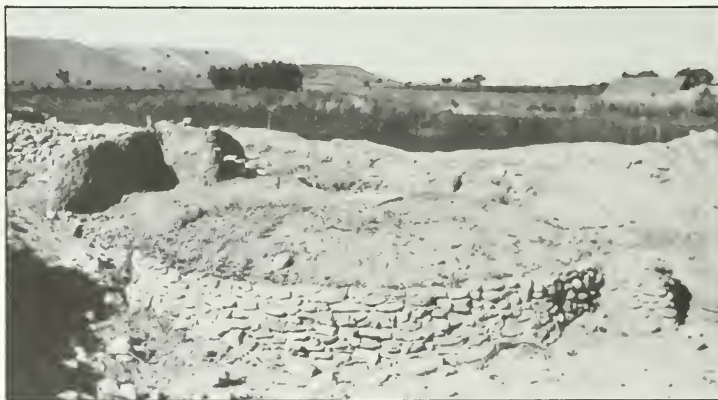
Figure 3.5. Roofed Kiva B, 1916. (Courtesy American Museum of Natural History).

Morris arbitrarily elected to roof Kiva B. For unclear reasons, he used a partially intact, cribbed-log kiva roof at Peabody House (now Square Tower House) in Mesa Verde as a model.¹² He justified the reconstruction to Nelson as being less costly than resetting the kiva's cobblestone walls in cement to withstand exposure. Up until 1984, the replaced flat roof, with its central hatchway at ground level, was noticeable in the southeast court (see Figure 3.5). However, reroofing this relatively minor construction proved to be a mistake. Because of the slope of the terrain and the kiva's situation in the lowest part of the site, underground water percolated into it. The roof prevented natural evaporation, making eventual backfilling of the structure the only possible solution for its preservation. It lies hidden beneath a thick layer of earth along a service road exiting from the southeast corner of the house compound.

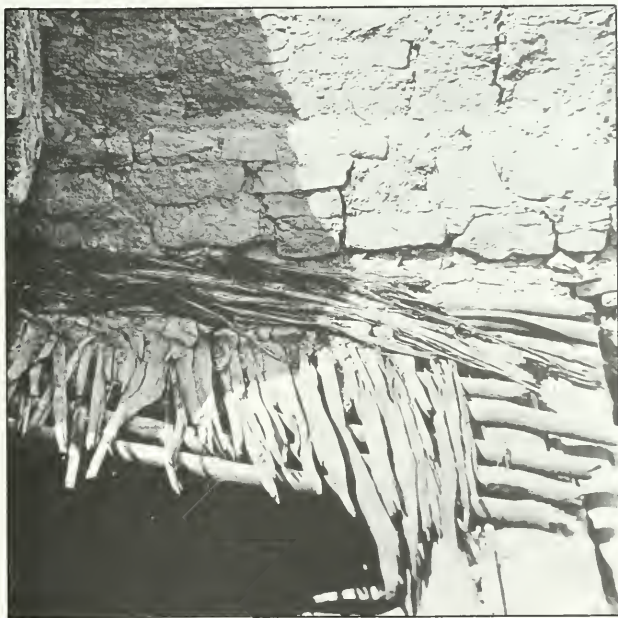
Figure 3.6. Exposed first-story roof of primary beams, cross poles, and strips of cedar bark.

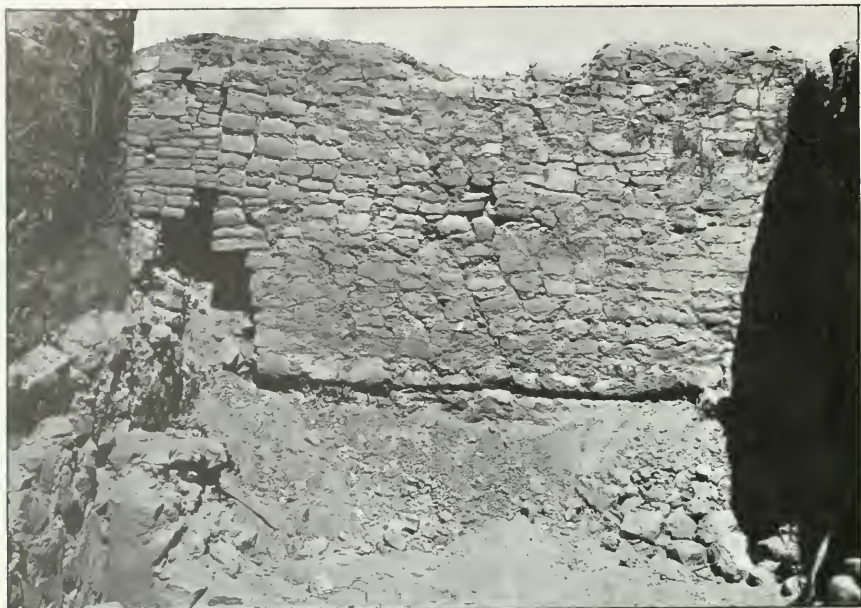
Figure 3.14. Mesa Verde-style wall built on top of Chaco debris in unidentified West Ruin room. (Courtesy American Museum of Natural History).

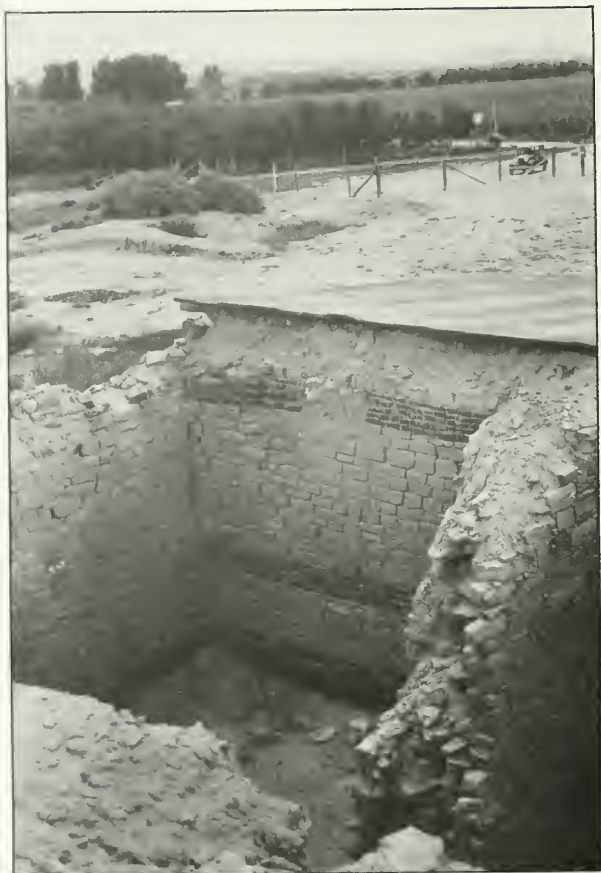
Figure 3.22. Room in southwest corner of the West Ruin showing bands of green stone inset within more typical sandstone masonry. Modern tar paper roof at center right covered a utility room during the 1920s. Mound at upper left was an aboriginal refuse dump.

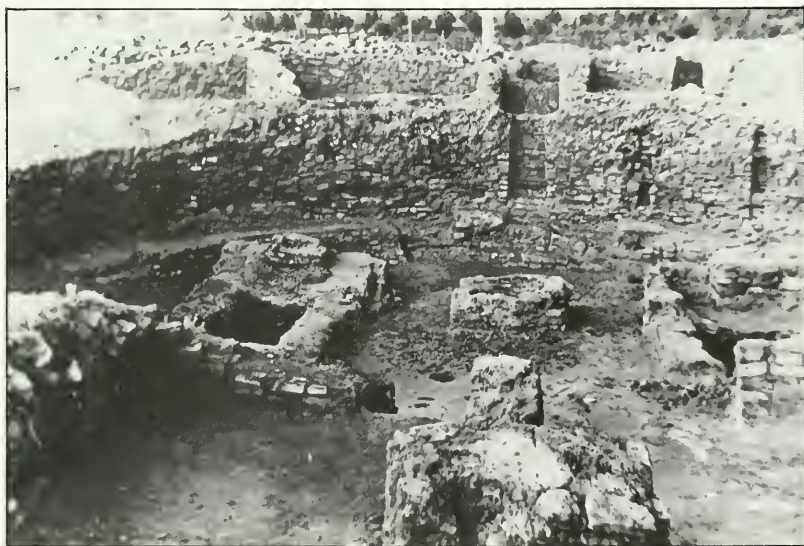
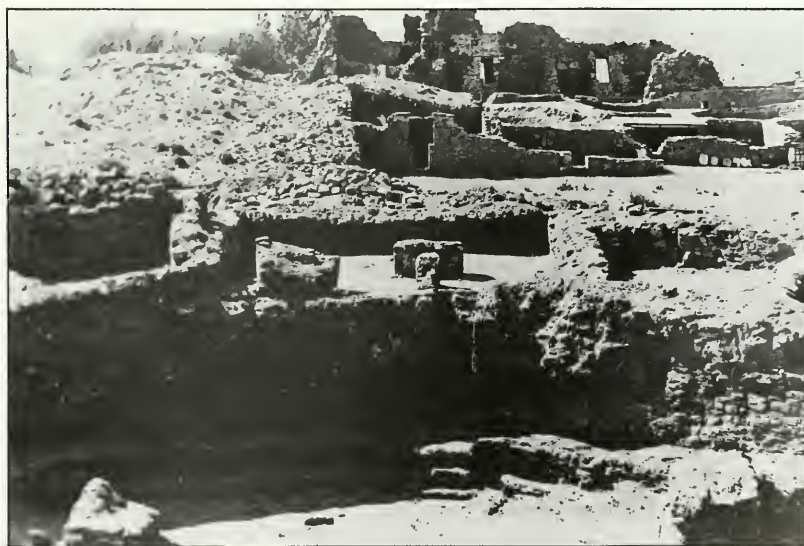
Figure 3.24. Excavated Great Kiva in 1921, showing floor features.
Above, view to south; below, view to north.

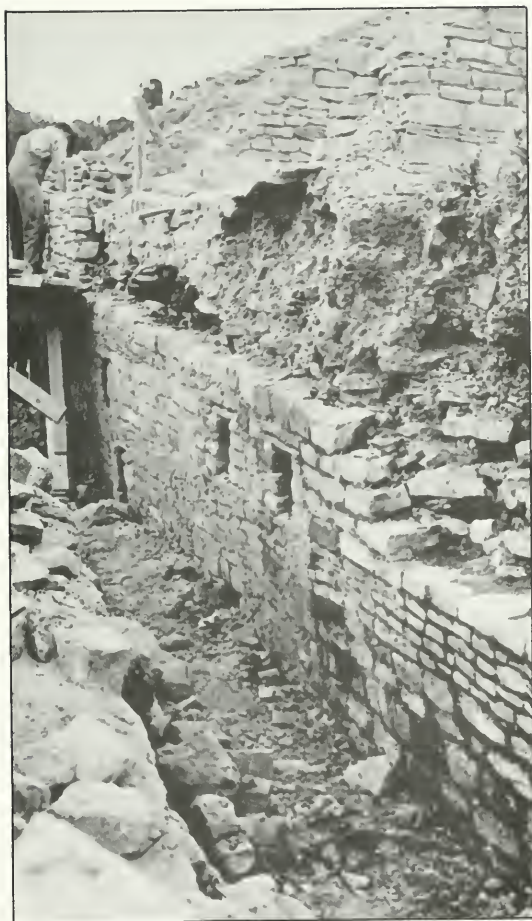
Figure 7.7. Resetting exterior wall of North Wing, 1934. Rubble core and shaped sandstone veneer evident.

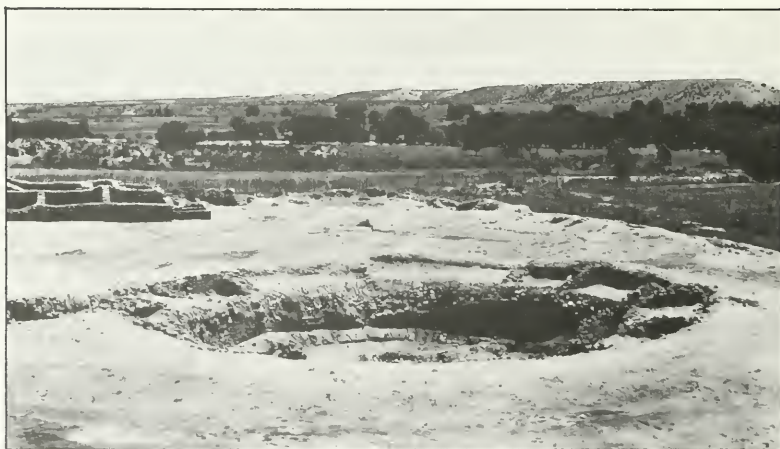
Figure 7.9. Deteriorated condition of Great Kiva prior to reconstruction in 1934.

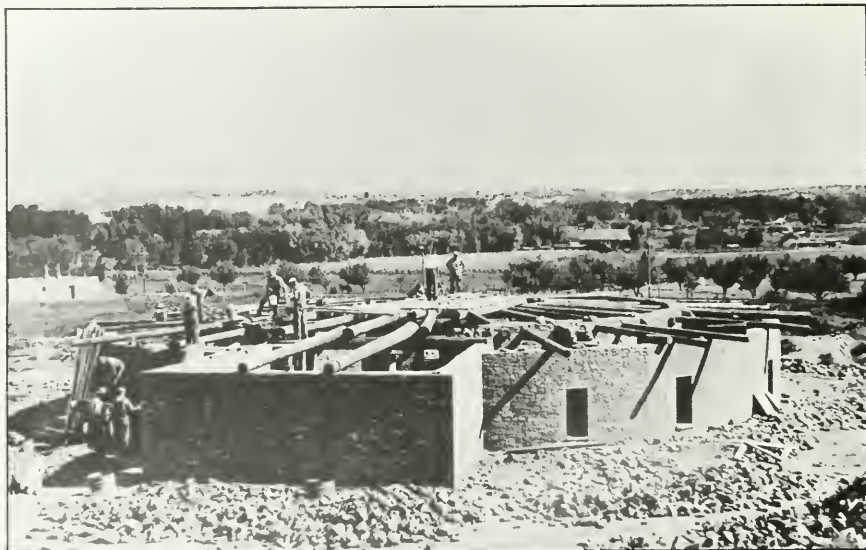
Figure 7.10. Erection of roof on restored Great Kiva, 1934. Custodian's residence at left center. Tatman's apple orchard at right center. Village of Aztec behind trees at upper center.

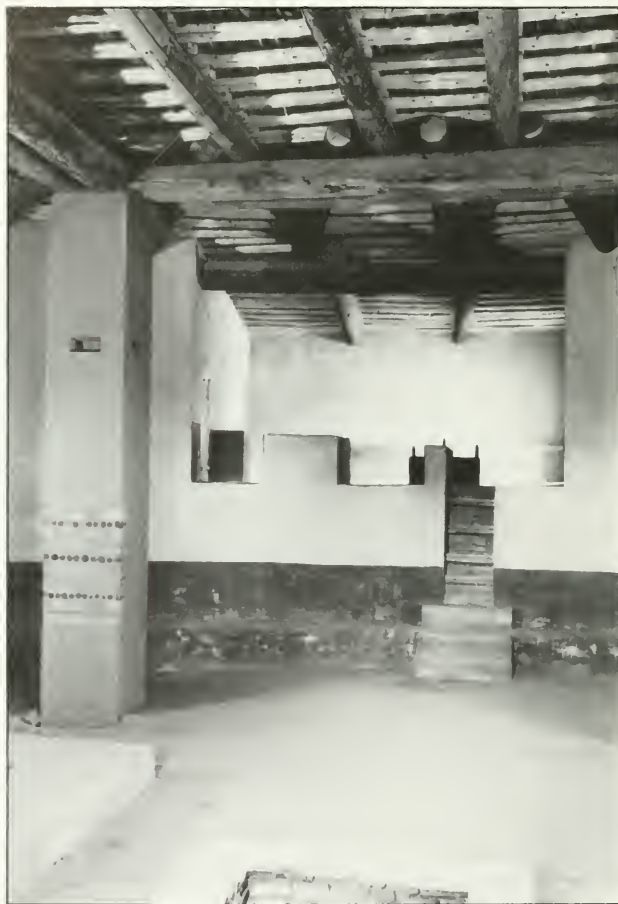
Figure 7.11. Interior of restored Great Kiva, looking toward north altar room. Crossbedded poles in roof support column left exposed to demonstrate method of construction.

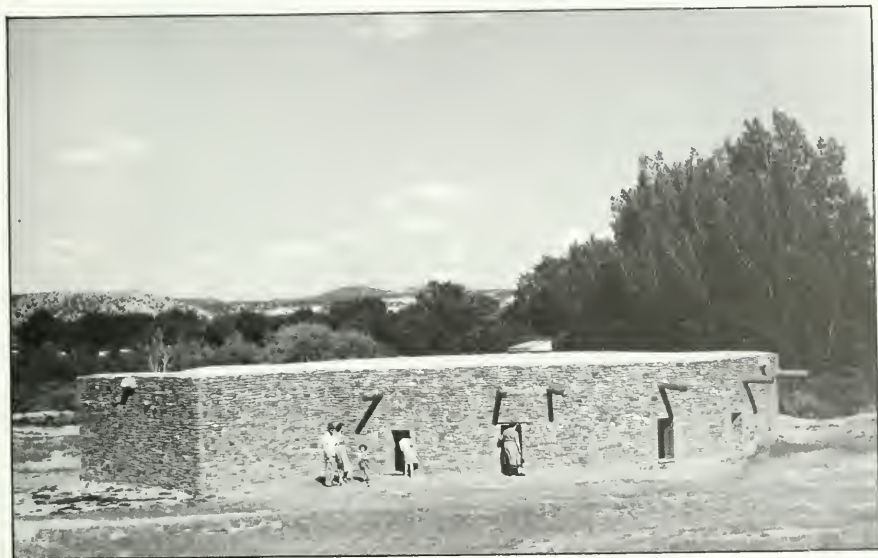
Figure 7.12. Reconstructed Great Kiva, northwest side. Doorways open into encircling surface rooms.

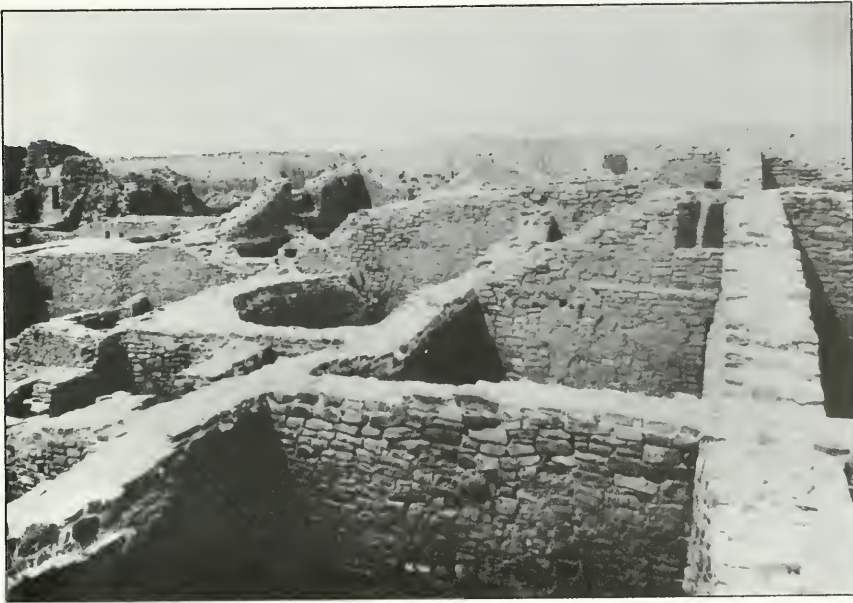
Figure 12.1. View over northeast corner of West Ruin showing cement wall capping.

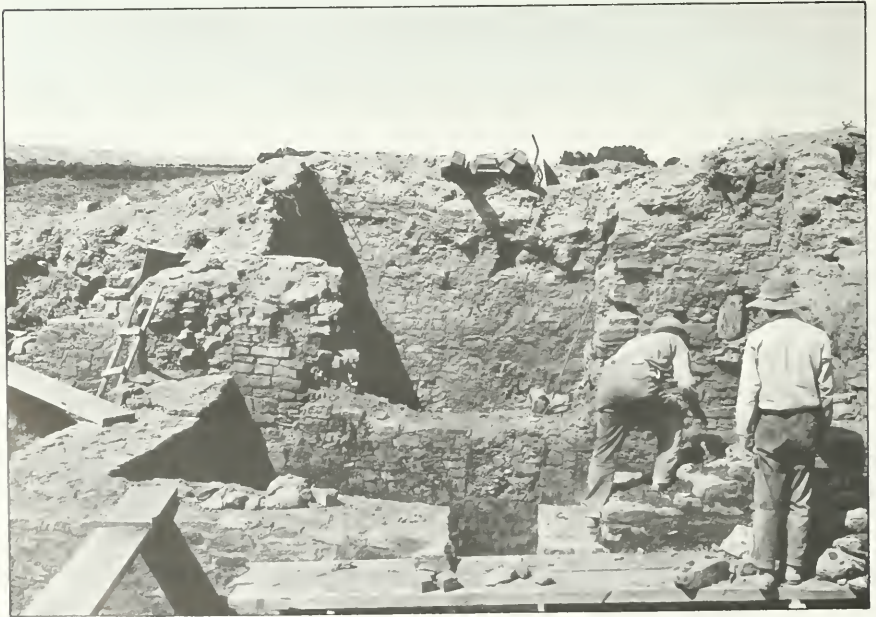
Figure 12.2. Two views of wall repairs, West Ruin, by American Museum of Natural History crews.

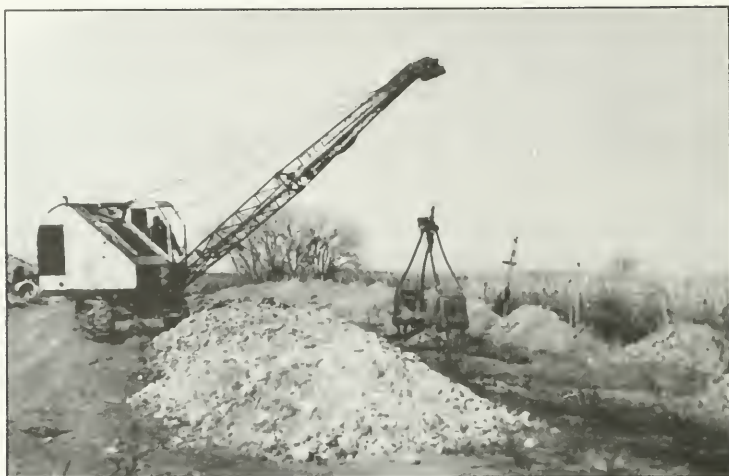
Figure 12.5. Dragline digging deep north drainage trench, 1946.

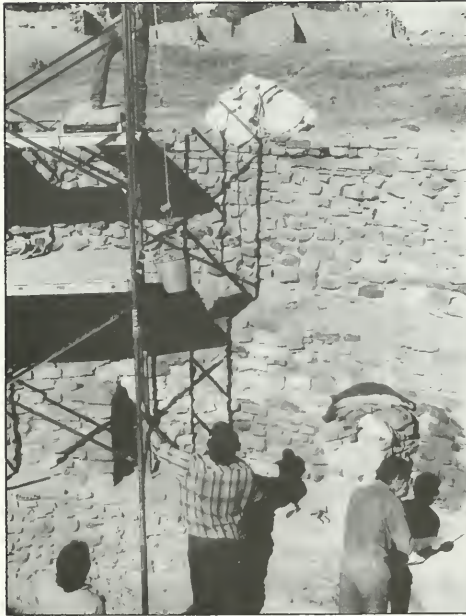
Figure 12.8. Routine maintenance stabilization at Aztec Ruins being done in connection with regional training exercises, May 1989.
